BIOLOGICAL RESOURCE ASSESSMENT and JURISDICTIONAL DETERMINATION REPORT

**Wildwood
Alamo Pintado and Old Mission Drive
Solvang, California 93463**

**Updated July 1 2024
781017101**

**BIOLOGICAL RESOURCE ASSESSMENT AND
JURISDICTIONAL DETERMINATION REPORT
Corner of Alamo Pintado Road & Old Mission Drive
Solvang, California**

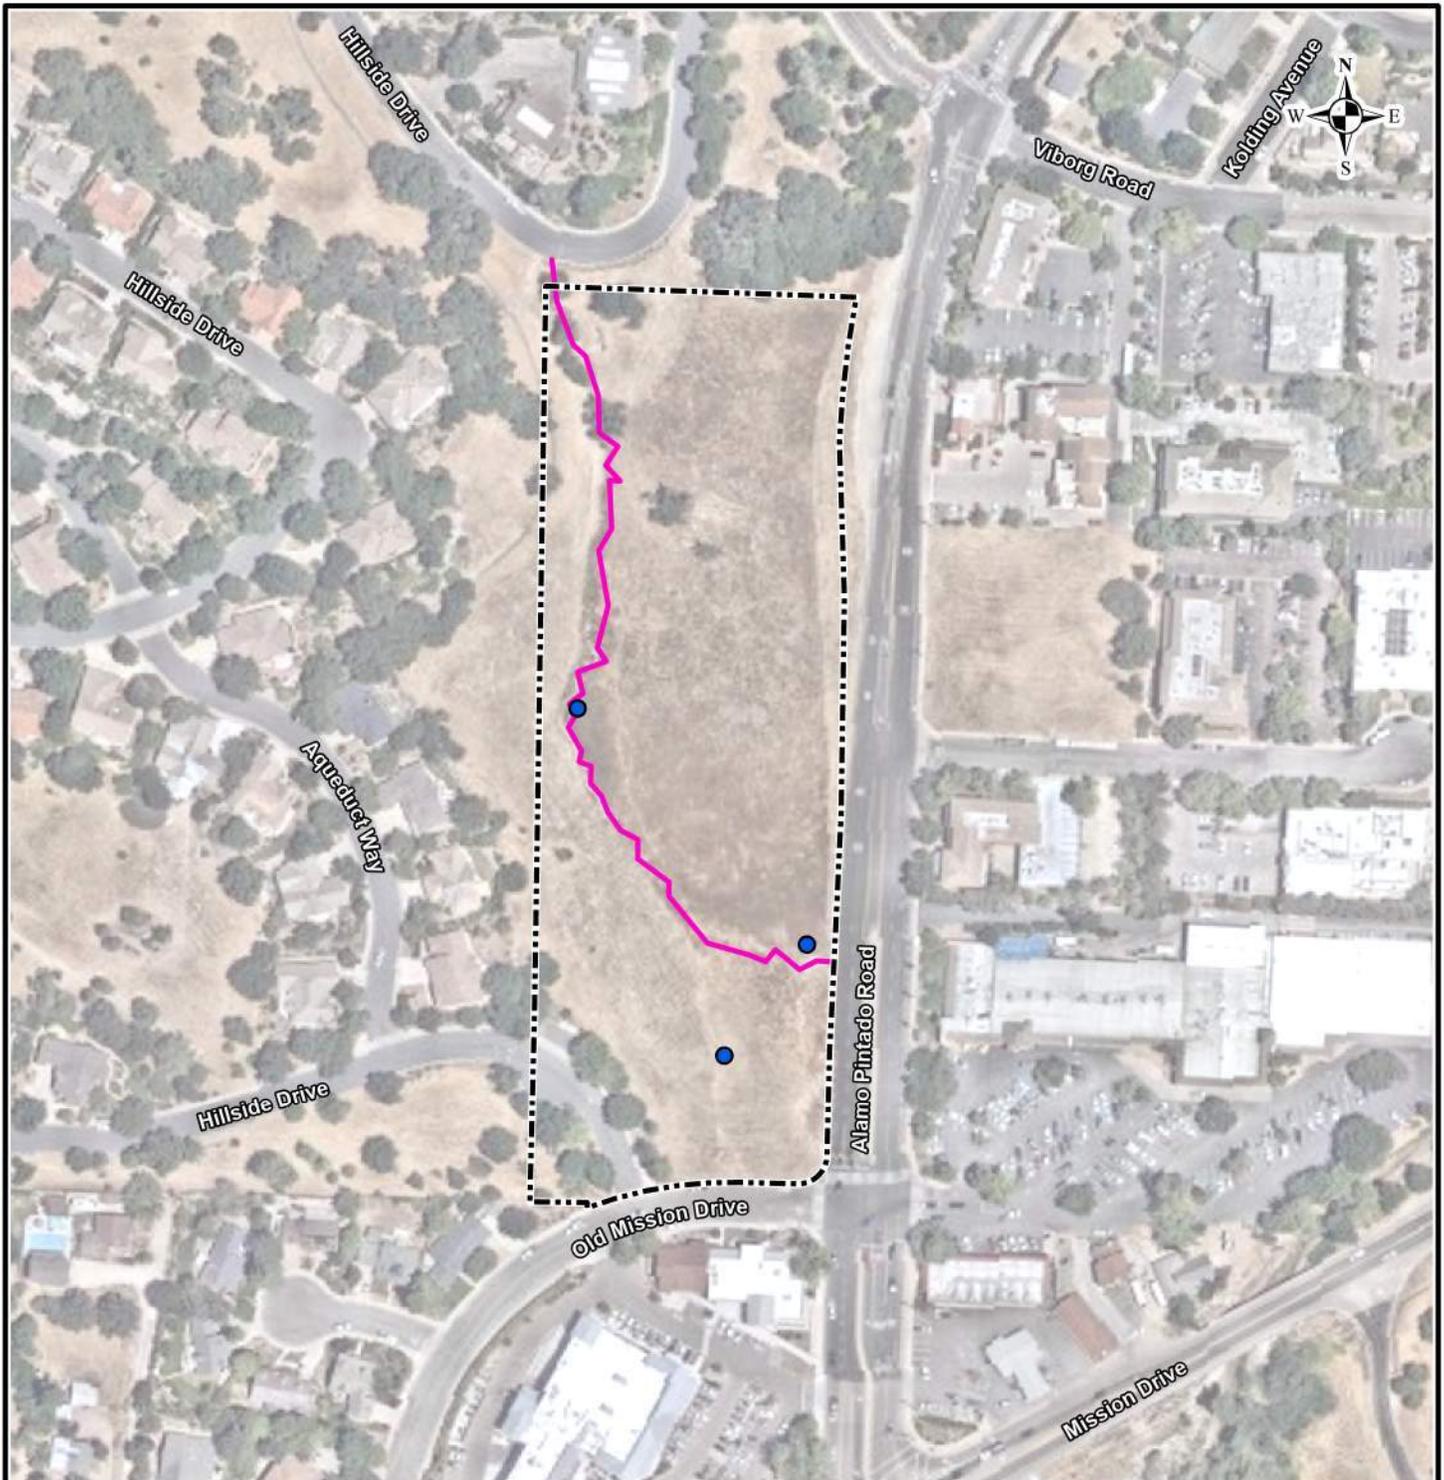
- Wetland Sampling Points
- Erosional Feature
- Approximate Project Boundary

Field surveys were conducted immediately after a rain event and surface water was observed flowing within the erosional feature. Additionally, Solvang is experiencing above average rainfall at this point in the year (NOAA 2024). The erosional feature was examined for wetland characteristics, but surveys determined that all necessary wetland parameters (hydrology, hydric soils, and hydrophytic vegetation) were not present. No Waters of the United States were observed within the Site. Photographs (**Appendix C**) and Wetland Determination Data Forms (**Appendix D**) were utilized to document Site conditions.

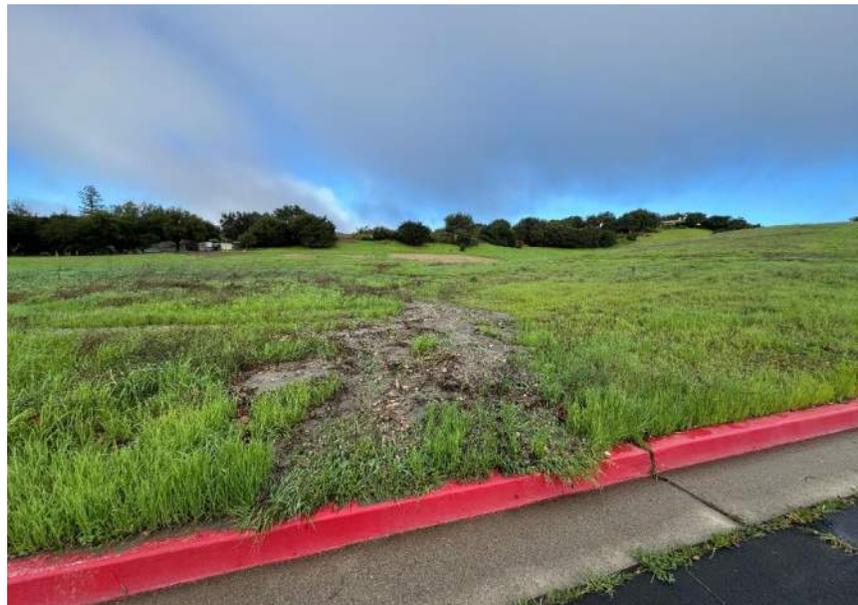
Date February 20, 2024	Photo No. 6
Direction Photo Taken: West	
Description: View of erosional feature on southern section of Site.

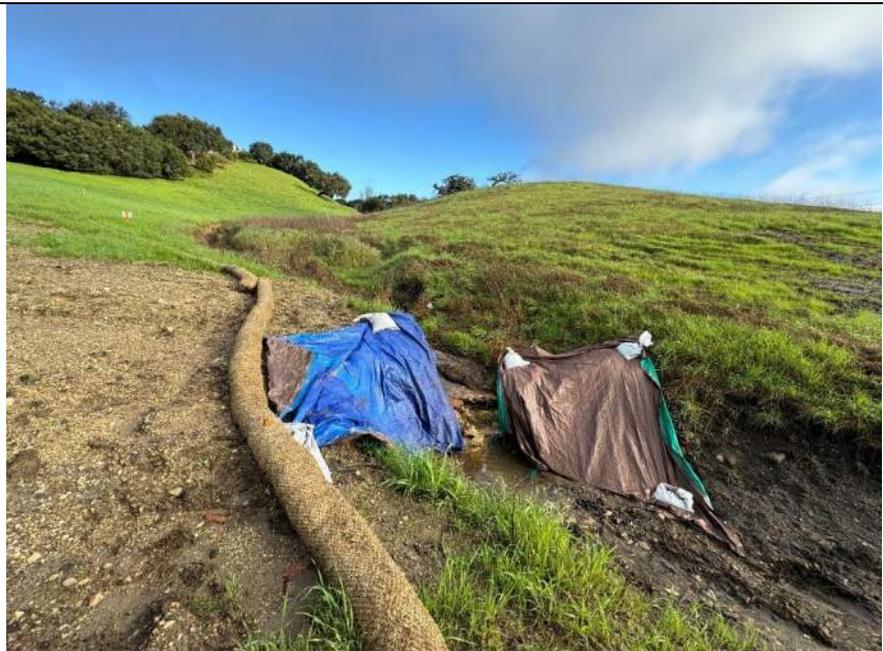
Date February 20, 2024	Photo No. 7
Direction Photo Taken: North	
Description: View of erosional feature near western boundary of Site.

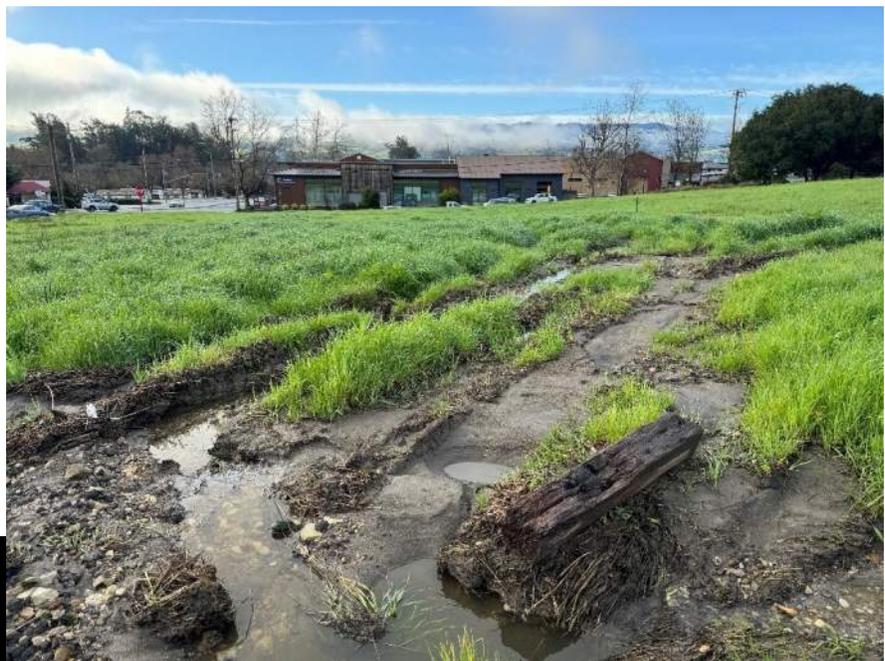
Date February 20, 2024	Photo No. 8
Direction Photo Taken: South	
Description: View of erosional feature near southern end of Site.

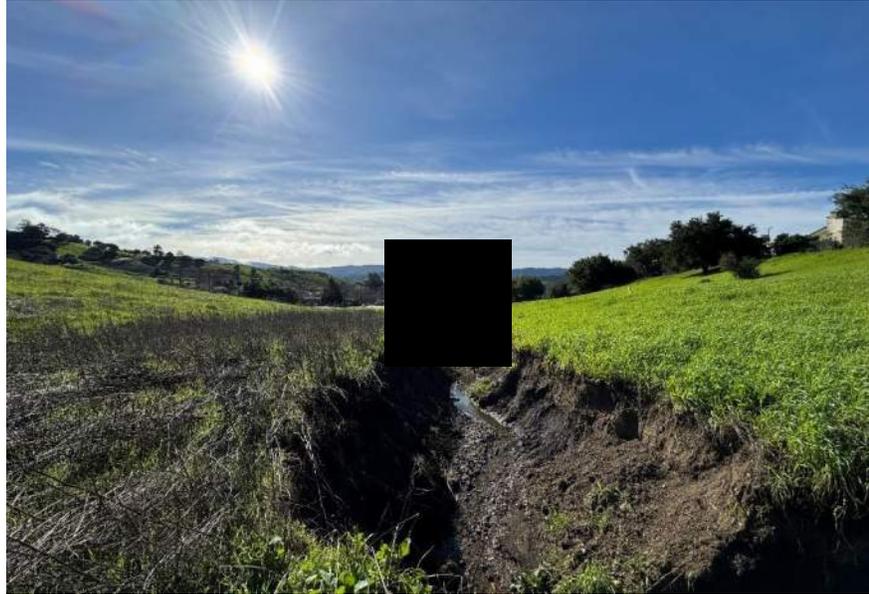
Date February 20, 2024	Photo No. 9
Direction Photo Taken: South	
Description: View of erosional feature near center of Site.

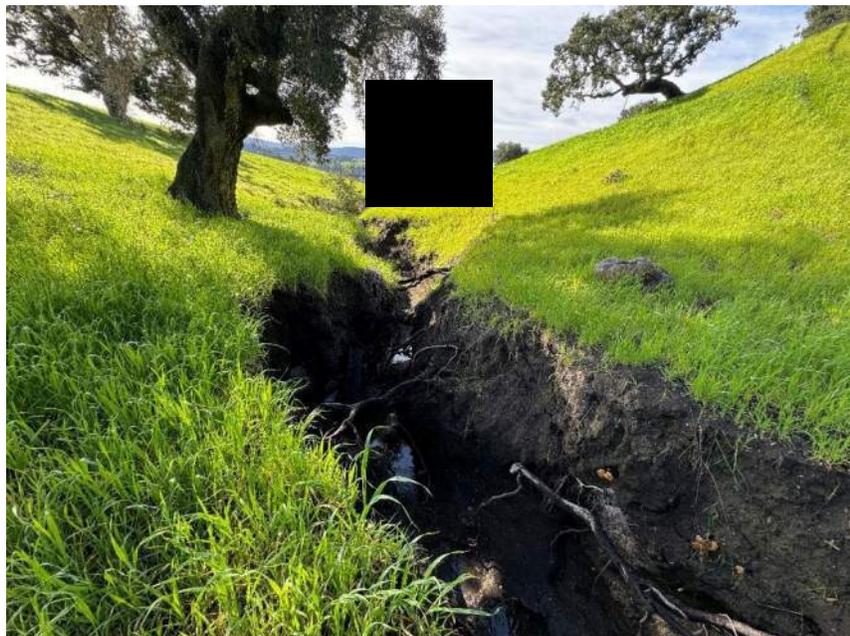
Date February 20, 2024	Photo No. 10
Direction Photo Taken: South	
Description: View of erosional feature near north of Site.

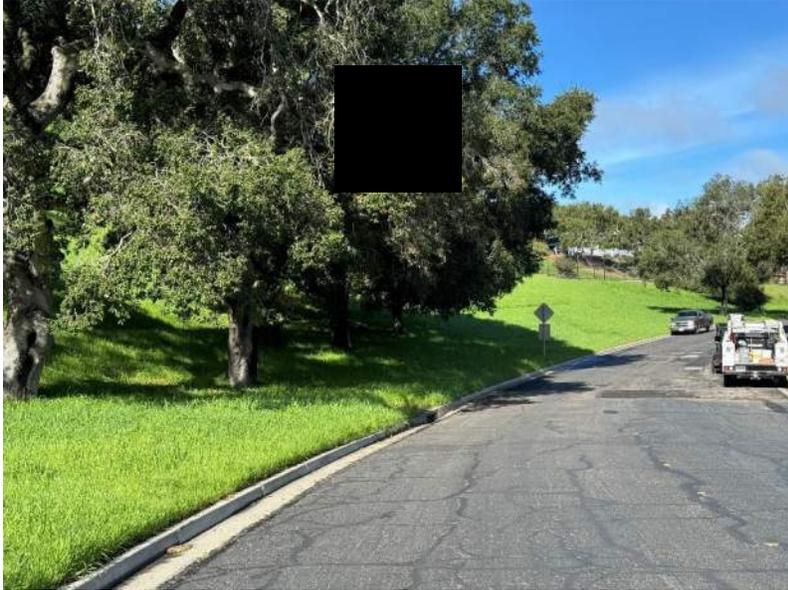
Date February 20, 2024	Photo No. 11

Direction Photo Taken: West		
Description: Viborg Road north of Site boundary, northern terminus of erosional feature.

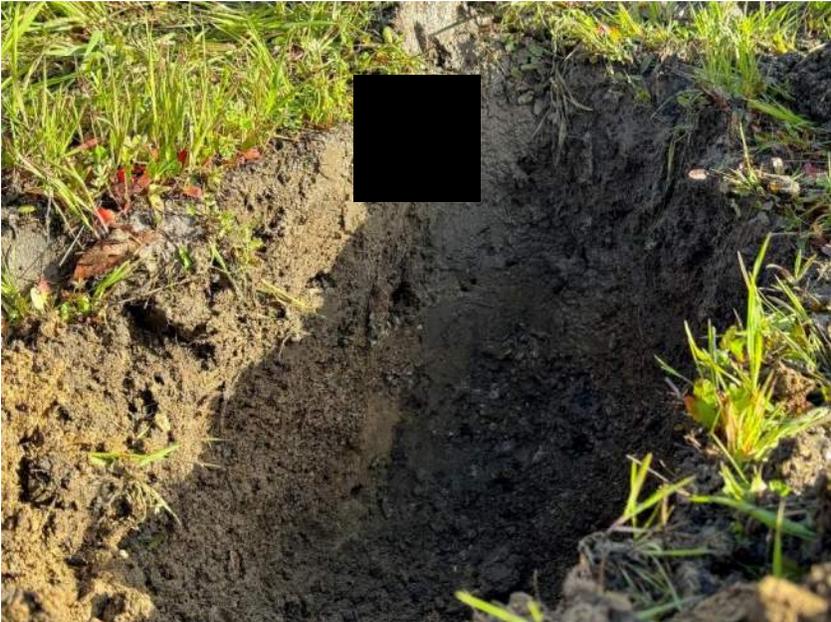
Date February 20, 2024	Photo No. 12

Direction Photo Taken: North		
Description: Soil profile from Plot 1.

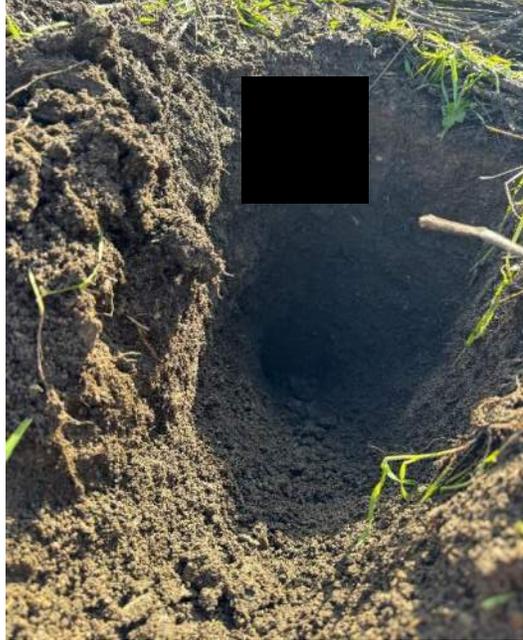
Date February 20, 2024	Photo No. 13
Direction Photo Taken: South	
Description: Soil profile from Plot 2.

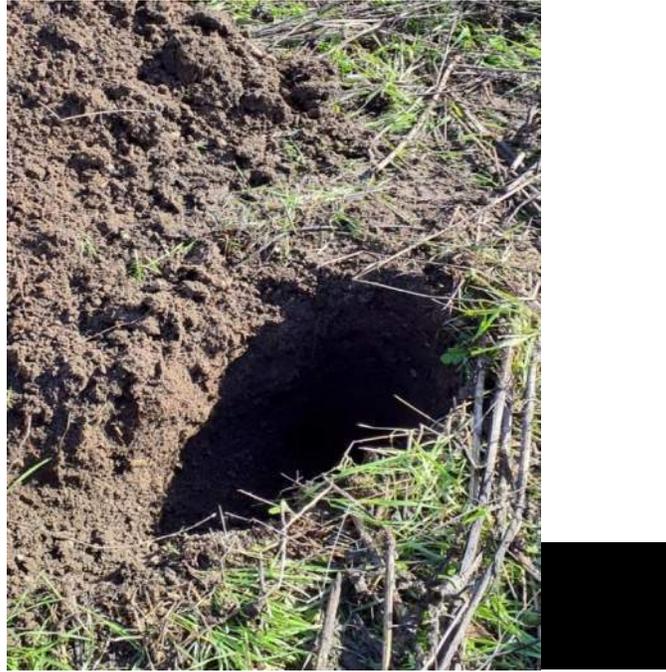
Date February 20, 2024	Photo No. 14
Direction Photo Taken: South	
Description: Soil Profile from Plot 3.
